Test Report

**Clear Ballot Group
ClearVote 1.3 Voting System
Certification Testing**

Wendy Owens, VSTL Program Manager

November 21, 2016

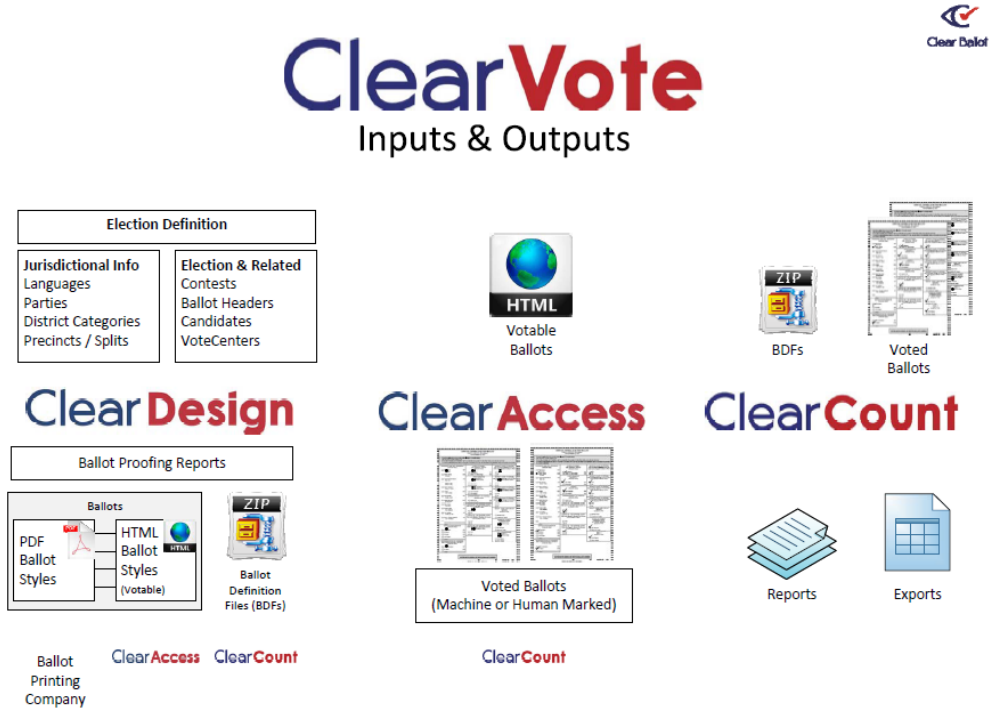
Figure 2.1 ClearVote Inputs & Outputs Diagram

The inputs and outputs of the ClearVote System depicted in Figure 2.1 are listed below:

- Inputs: Election Definition
- Outputs: Ballot proofing reports, PDF ballot styles, HTML Anywhere ballot marking files, Ballot Definition files

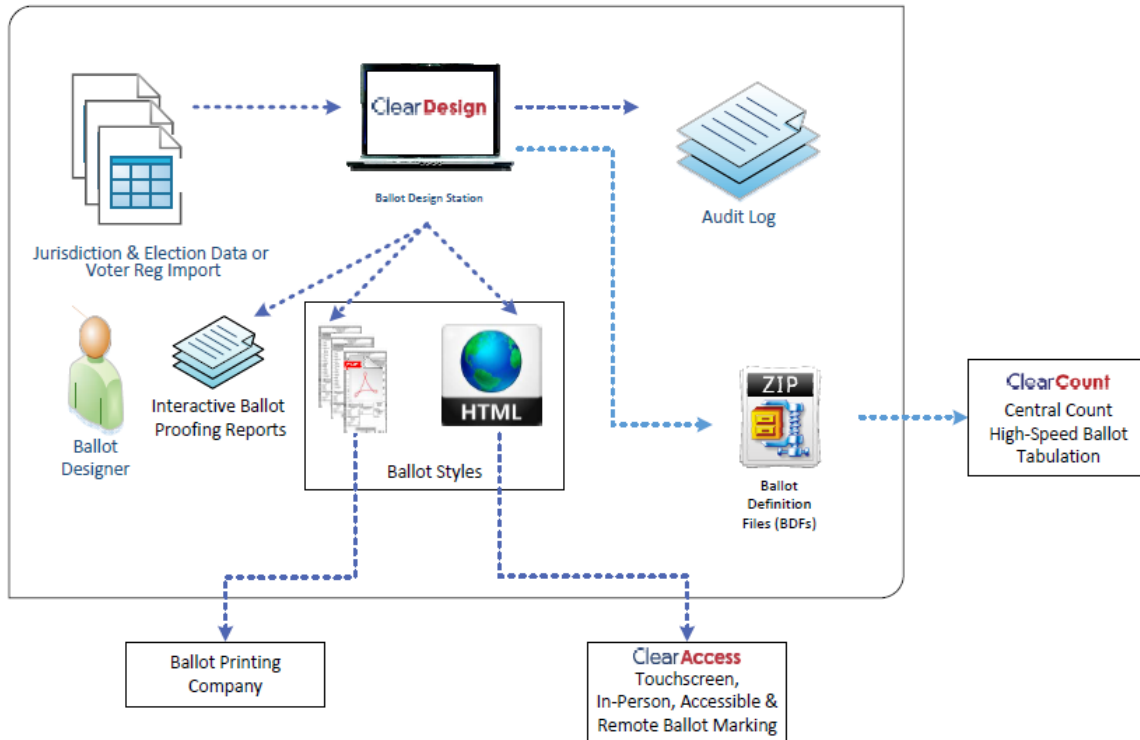
Figure 2.2 ClearDesign Interactive, Ballot Design, Layout, and Proofing Diagram

As illustrated in Figure 2.2, ballot design, proofing, layout, and production are accomplished in ClearDesign, the ballot design component of the ClearVote product family. The ClearDesign system consists of the following physical components (all of which are unmodified COTS hardware and are connected via closed, wired Ethernet connections): DesignServer, DesignStation(s), and router.

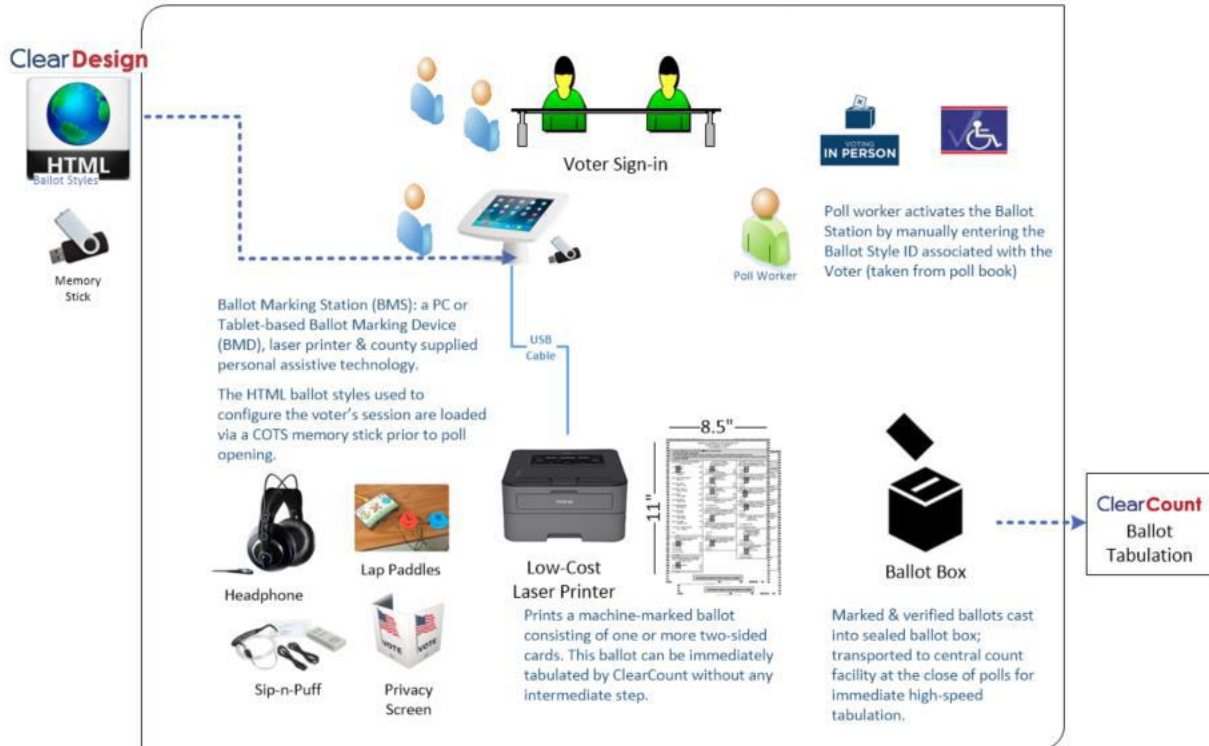
Figure 2.3 ClearAccess Touchscreen, In-Person, and Accessible Ballot Marking Diagram

ClearAccess, depicted in figure 2.3, is an accessible touchscreen ballot marking device (BMD) used for the creation of paper ballots that can be scanned and tabulated by ClearCount. The ClearAccess ballot marking system consists of one or more Ballot Marking Stations (BMS) having the following physical components (all of which consist of standalone, unconnected, unmodified COTS hardware): Ballot Marking Device (BMD), privacy screen, Personal Assistive Technology Devices (PATs), USB flash drive, and laser printer.

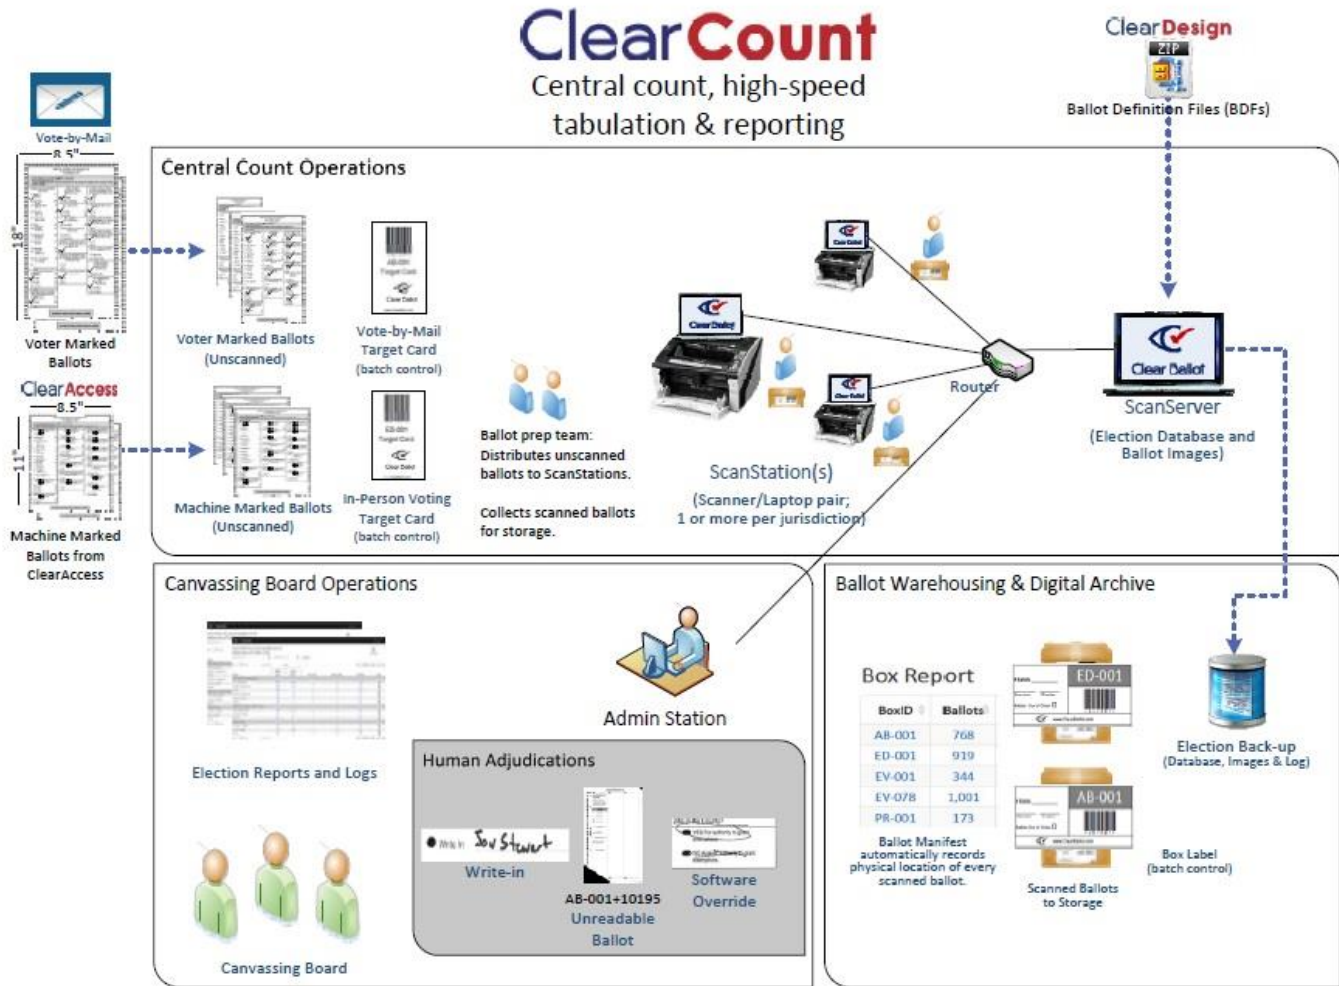
Figure 2.4 ClearCount Central Count Tabulation and Reporting Diagram

Tabulation and reporting at the central location is accomplished by ClearCount, as depicted in Figure 2.4.

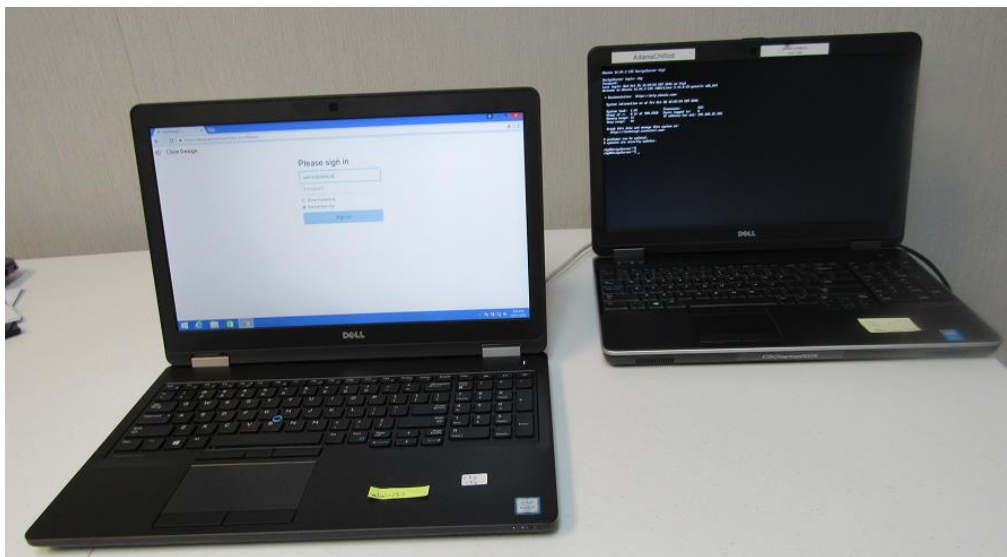
Photograph 2-1 ClearDesign Configuration

The tested configuration for ClearDesign consists of the following components:

- ClearDesign Server Laptop (Dell Precision M2800 or Dell Laptop Latitude E5570)
- Client Laptop (Dell Laptop Latitude E5570)
- Brother Laser Printer (Model: HL-L2340DW) (not pictured)
- TRENDnet Switch (Model: TEG-S80g) (not pictured)

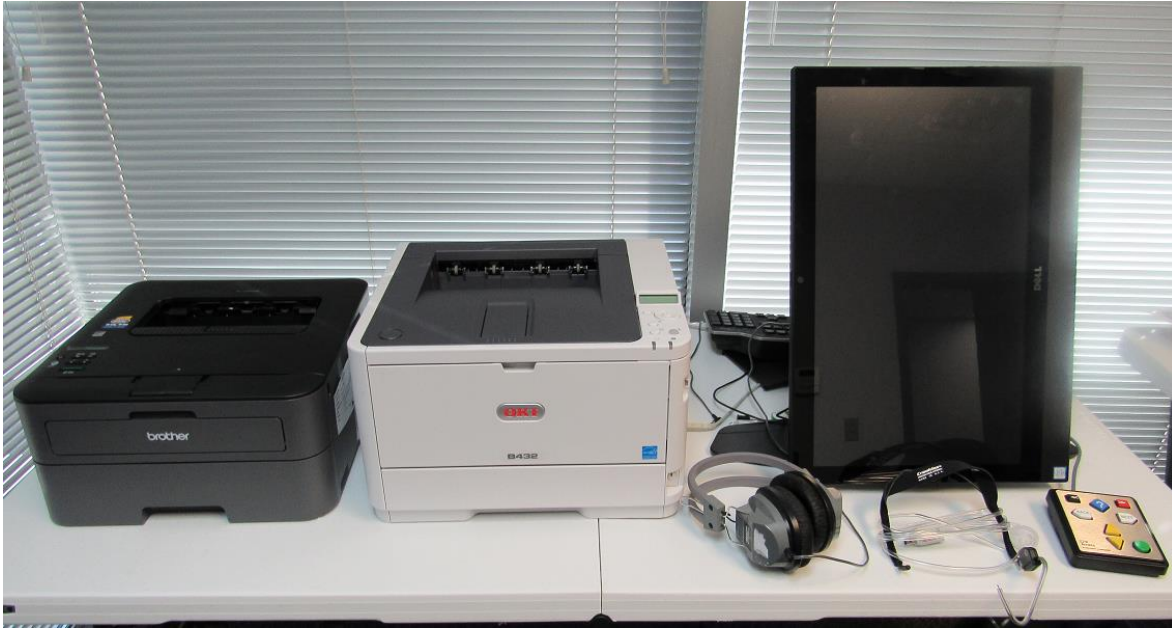
Photograph 2-2 ClearAccess Configuration

The tested configuration for ClearAccess consists of the following components:

- ClearAccess All-in-One (Model: Dell Optiplex 3240)
- Brother Laser Printers (Model: HL-L2340DW)
- Oki Laser Printers (Model: B432dn)
- HP InkJet Printer (Model: HP7612) (*not pictured*)
- Storm EZ Access Keypad (Model: EZ08-22201)
- Origin Instruments Sip/Puff Breeze (Model: BZ2)
- Over-ear Stereo Headphone (Model: Hamilton Buhl HA-7)
- ClearAccess Laptop (Model: Dell Inspiron 15 5000 Series) (*not pictured*)
- HP OfficeJet 100 Mobile printer (*not pictured*)
- ElectionSource Table Top Voting Booth Privacy Screen (Model: VB-60B) (*not pictured*)
- Battery Backup (APC Smart-UPS 1500 (for the All in One PC) (*not pictured*))
- Battery Backup (APC Smart-UPS 2200 (for laser printers) (*not pictured*))

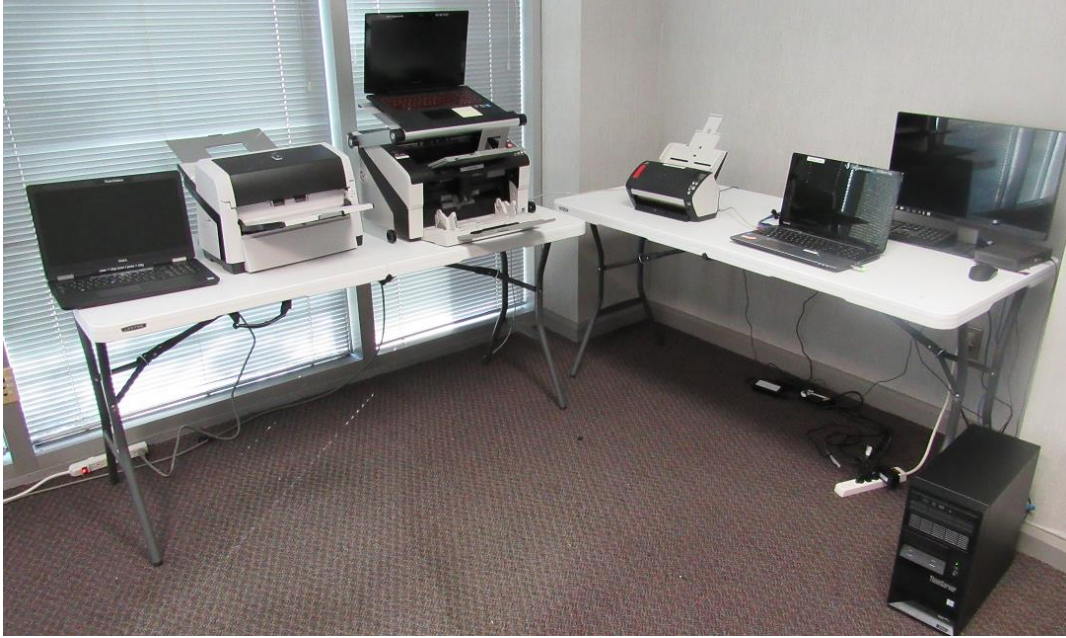
Photograph 2-3 ClearCount Configuration

The tested configuration for ClearCount consists of the following components:

- ScanServer Laptop (Lenovo: Y50-70 or Dell: E5570 or HP: ProBook 4540s)
- ScanServer Tower (Lenovo: TS140)
- ScanStation Laptop (Toshiba: S55-A5167 or Lenovo: Y50-70 or Dell: E5570)
- ScanStation Tower (Apex Boxx Server used for IBML Image-Trac Lite Scanner) (*not pictured*)
- ClearCount Scanner (Fujitsu fi-6800)
- ClearCount Scanner (Fujitsu fi-6670)
- ClearCount Scanner (Fujitsu fi-7180)
- ClearCount Scanner (IBML ImageTrac Lite Scanner 6000 series) (*not pictured*)
- ClearCount Scanner (IBML ImageTrac DS series Scanner 1210 or 1155) (*not pictured*)
- TP-LINK VPN Router (Model: TL-R600VPN) (*not pictured*)
- Battery Backup (APC Smart-UPS 1500 (for Fujitsu scanners) (*not pictured*))
- Battery Backup (APC Smart-UPS 2200 (for IBML scanners) (*not pictured*))
- NETGEAR ProSAFE FVS318G 8-Port Gigabit VPN Firewall (Model: FVS318G)
